Debris/Ice/TPS Assessment and Integrated Photographic Analysis of Shuttle Mission STS-74

Gregory N. Katnik, Barry C. Bowen, Jill D. Lin

*Gregory N. Katnik, Barry C. Bowen, Jill D. Lin,
Vehicle Engineering/Mechanical System Division/ET-SRB Branch,
Kennedy Space Center, Florida*

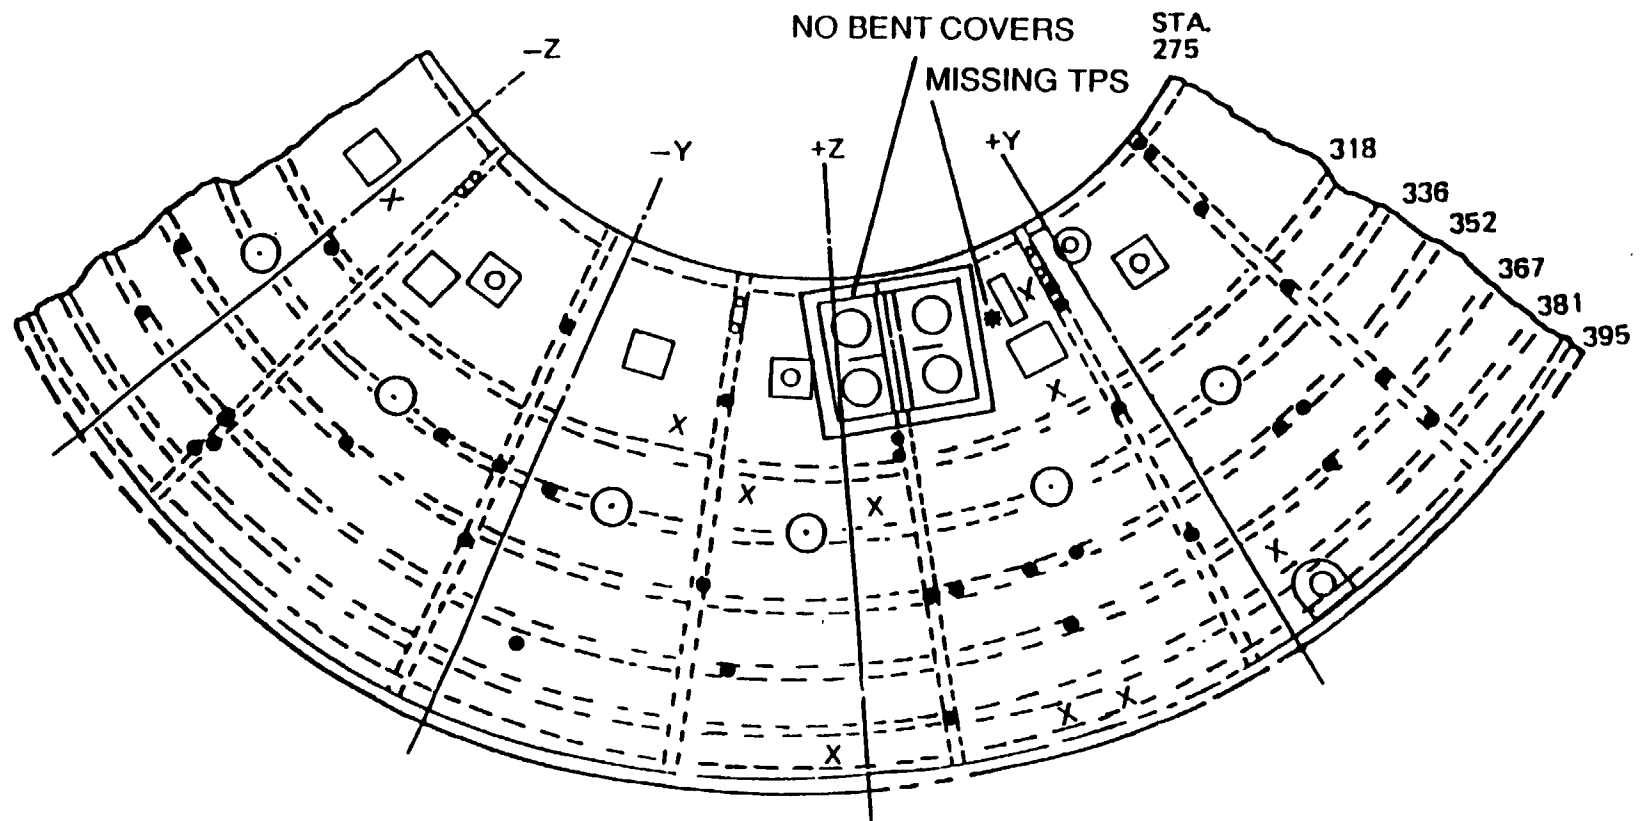
Figure 2 : LH Frustum

The LH frustum exhibited a 2-inch diameter divot with sooted substrate between the BSM cluster and the +Y axis near the XB-275 ring frame. The number of debonds (37) over fasteners was average (Figure 2). The ten MSA-2 acreage debonds was unusual. Surveillance for unfavorable trends will continue on the next vehicle. Hypalon paint was blistered/missing along the XB-395 ring frame where BTA closeouts had been applied. However, most of the exposed BTA substrate was not sooted. The BSM aero heat shield covers had locked in the fully opened position.

MISSING TPS

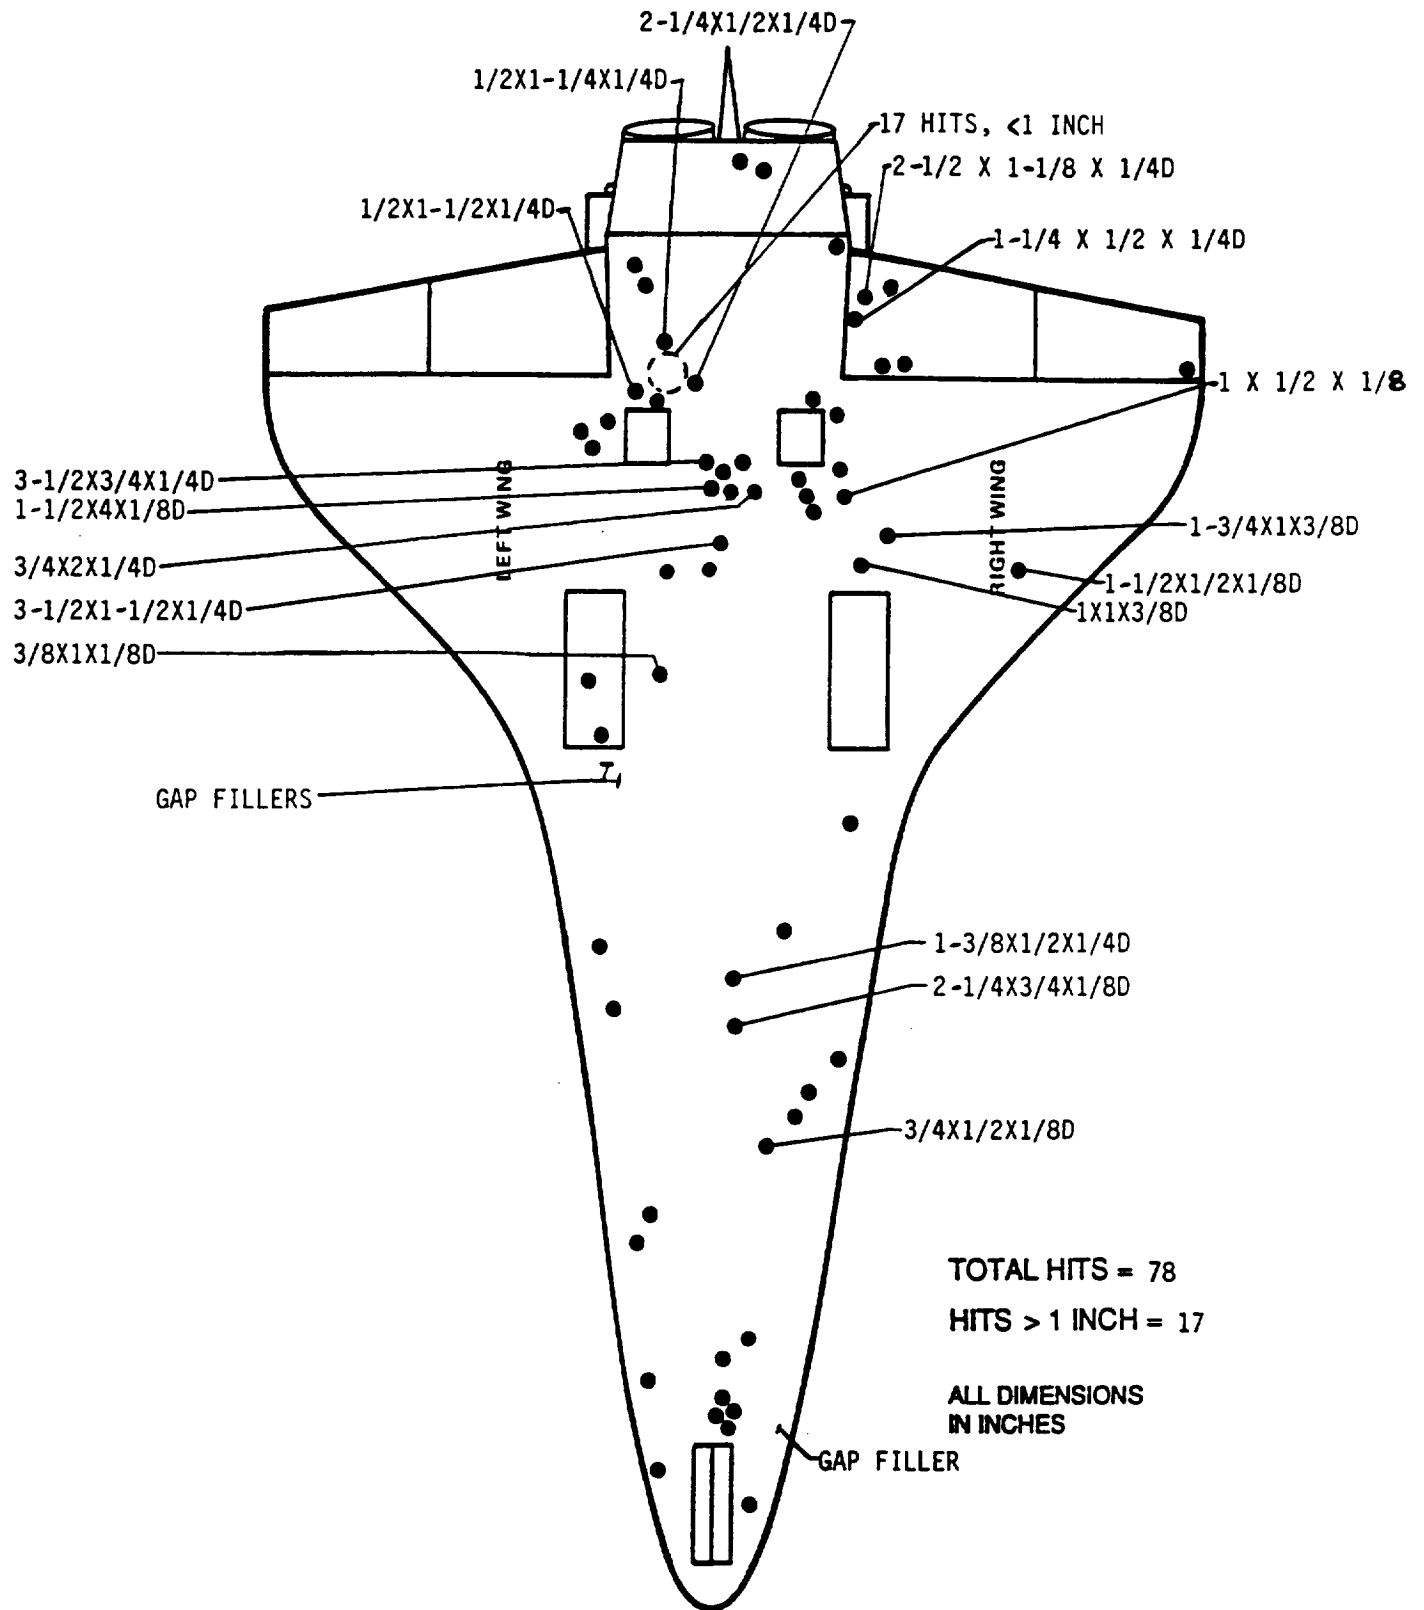
Figure 3 : Orbiter Lower Surface Debris Map

A post landing debris inspection of OV-104 Atlantis was conducted 20-21 November 1995 at the Kennedy Space Center on SLF runway 33 and in the Orbiter Processing Facility bay #1. This inspection was performed to identify debris impact damage and, if possible, debris sources. The Orbiter TPS sustained a total of 116 hits, of which 21 had a major dimension of 1-inch or larger. This total does not include the numerous hits on the base heat shield attributed to SSME vibration/acoustics and exhaust plume recirculation. A comparison of these numbers to statistics from 57 previous missions of similar configuration (excluding missions STS-23, 25, 26, 26R, 27R, 30R, and 42, which had damage from known debris sources), indicates the number of hits 1-inch or larger was average while the total number of hits was less than average (Reference Figures 3 and 4. Note: no debris impacts were recorded on the left and right sides of the fuselage. The figures have been omitted accordingly).

In summary, the number of hits 1-inch or larger was average while the total number of hits was less than average when compared to previous missions (Figure 5).
